| Project Number: 201801 | Date: 05.10.2018 |
| Part #: FPH25409-D40B3013M / F185-1220C6DSYB1 | Tech: S.Rudi |
| Part description: Pitch 2.54mm: Pin Header 90°Angle / Female Header DIP HTSW | |

**DESIGN QUALIFICATION TEST REPORT  
FPH25409-D40B3013M / F185-1220C6DSYB1**

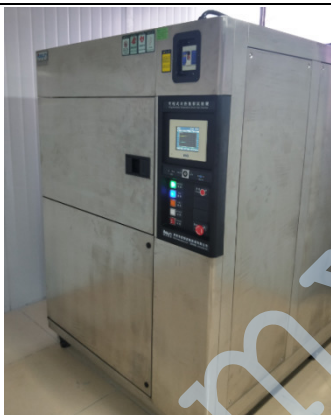
Figure 1: Thermal Shock & Aging Chamber

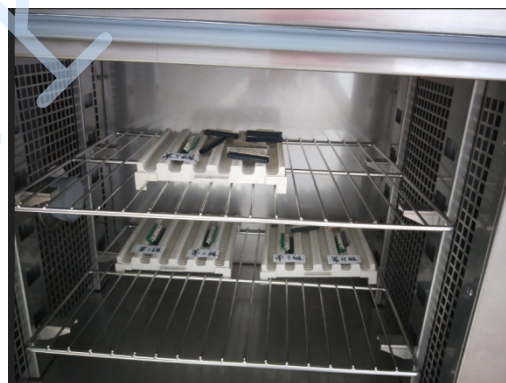
Figure 2: Overview samples under test

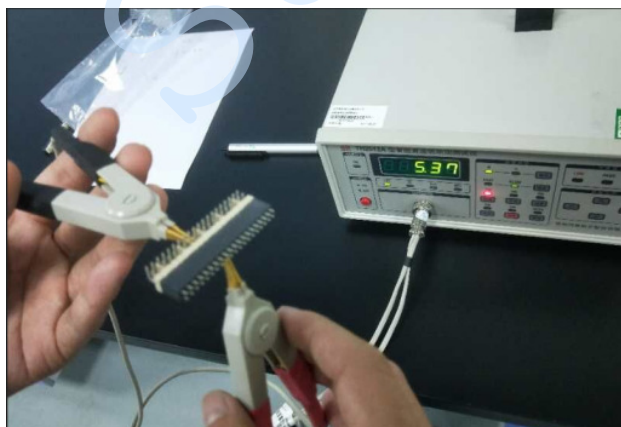
Figure 1: Overview samples under test

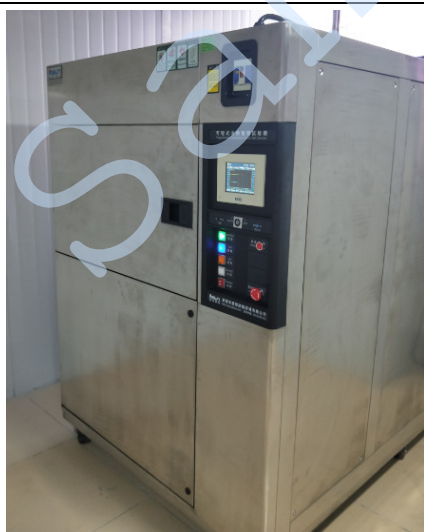
Figure 1: Thermal Shock & Aging Chamber

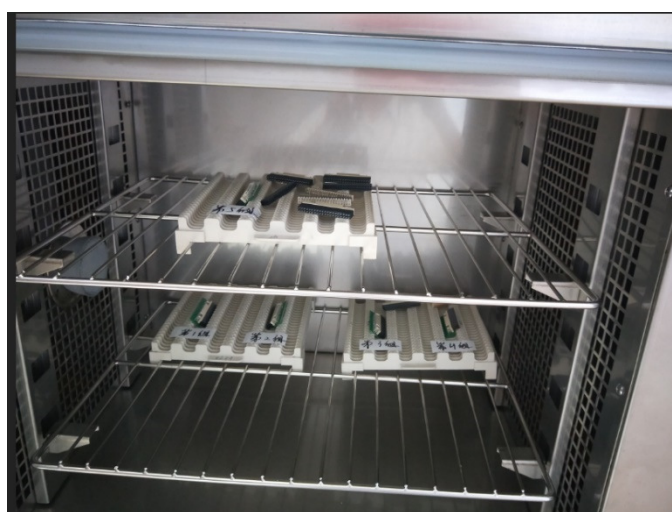
Figure 2: Overview samples under test

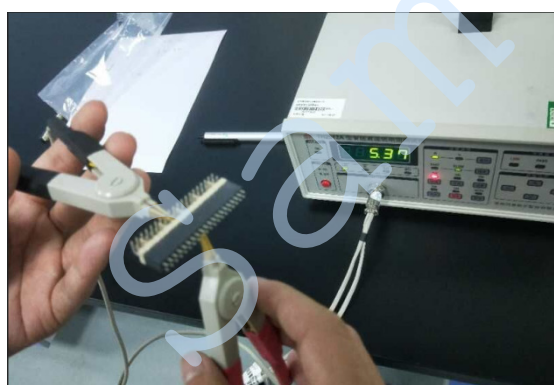
Figure 1: Overview samples under test

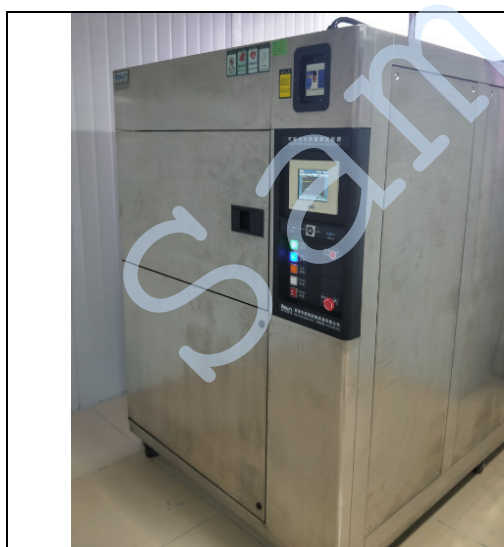
Figure 1: Thermal Shock & Aging Chamber

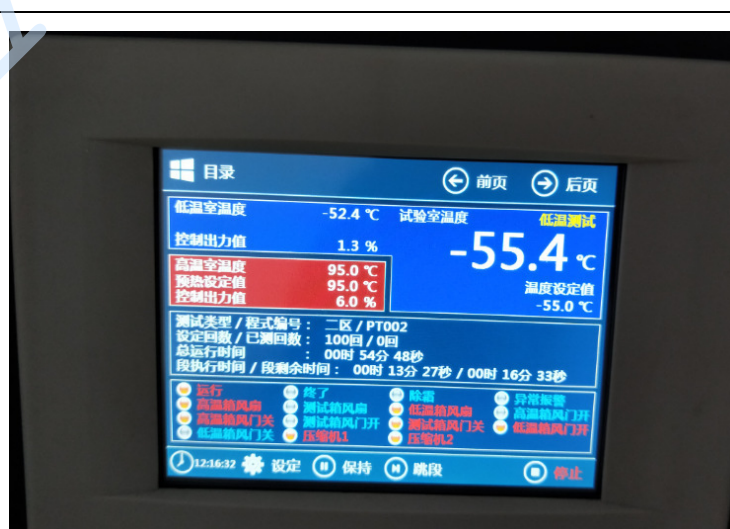
Figure 2: The setting test condition parameters

6.5 Test Conditions: -55° C to +85° C 1/2 hour dwell, 100 cycles.

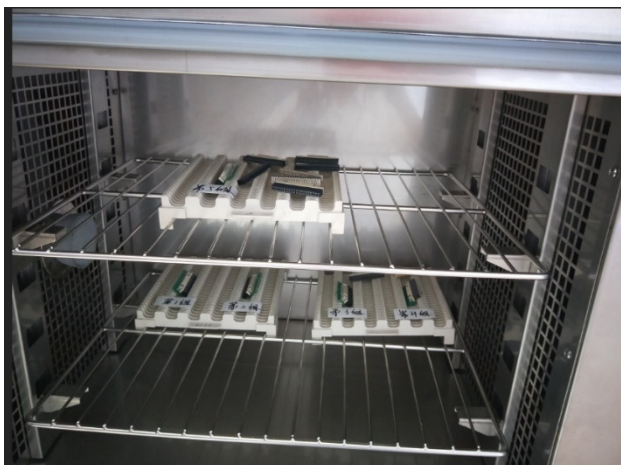
Figure 3: Overview samples under test

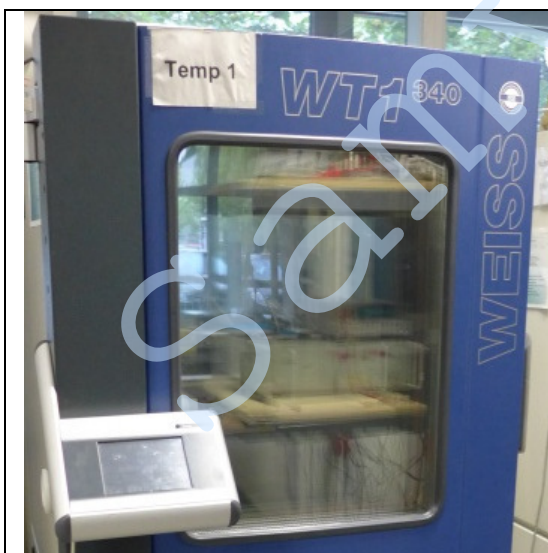
The current-temperature derating test was performed in a temperature environmental stress chamber as shown in Figure 2. The used measurement equipment is shown in Figure 3. A device list is given in Table 1.

Figure 2: Overview, Temperature Environmental Stress Chamber (Weiss Umwelttechnik GmbH, Type: WT1-340)
